Pool Inspection Report At:
123 Any Street, Your Town, WI

Inspection Date:
July 13, 2016

Prepared By:
Buyers Edge Home Inspections
1968 Maple Dale Rd
Trenton, WI 53090

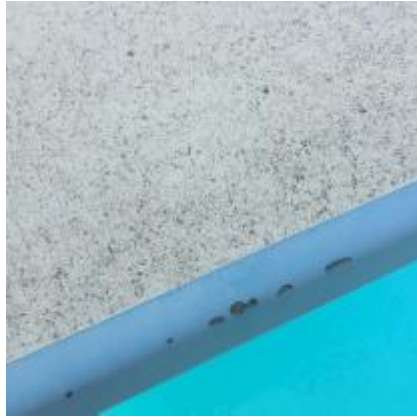
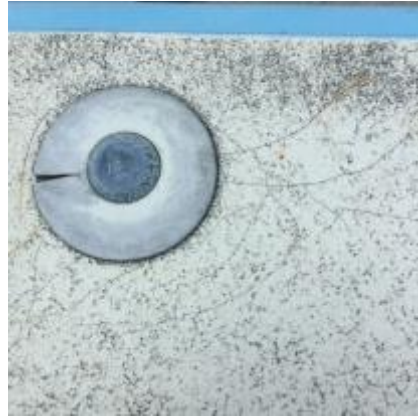
- **Diving board shows signs of age. Cracking is apparent and may be signs the diving board could suffer failure. Recommend replacing the diving board.**
- **No Separation between the shallow and deep ends of pool was installed. Recommend adding a rope barrier.**
- **Sub panel that houses pool breaker has an open knock out. Knock out should be filled.**

Figure 1:Cracking on the diving board.

Figure 2:Cracking on the diving board.

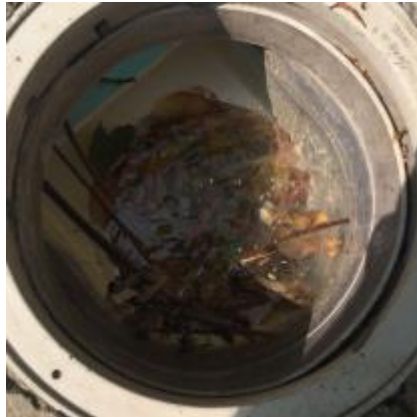
Figure 3:Dirty Pool strainer.

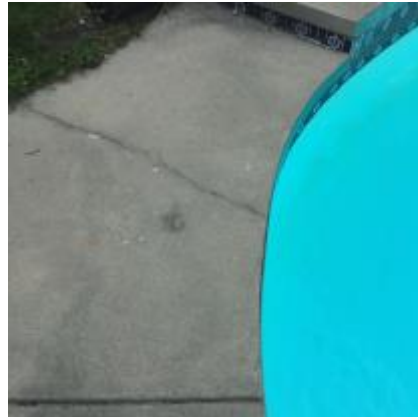
Figure 4:Cracking on the concrete.

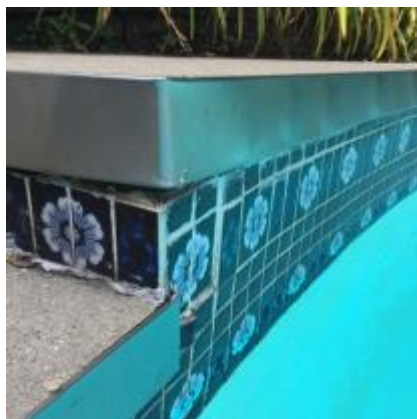
Figure 5:Pushed up coping.

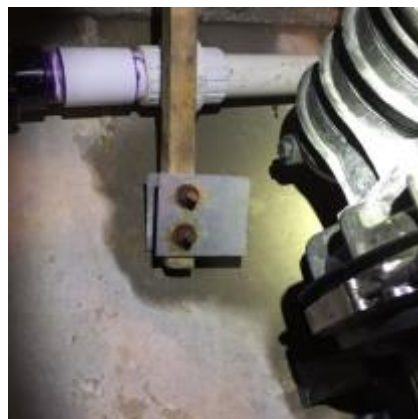
Figure 6:Leaking around the pump.

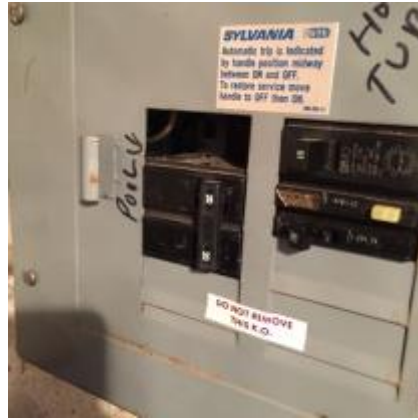
Figure 7: Open knock out.
